LAWRENCE
LIVERMORE
NATIONAL
LABORATORY

LLNL-TR-648143

A Visual Description of the Concrete Exterior of the Cactus Crater Containment Structure

October 2013

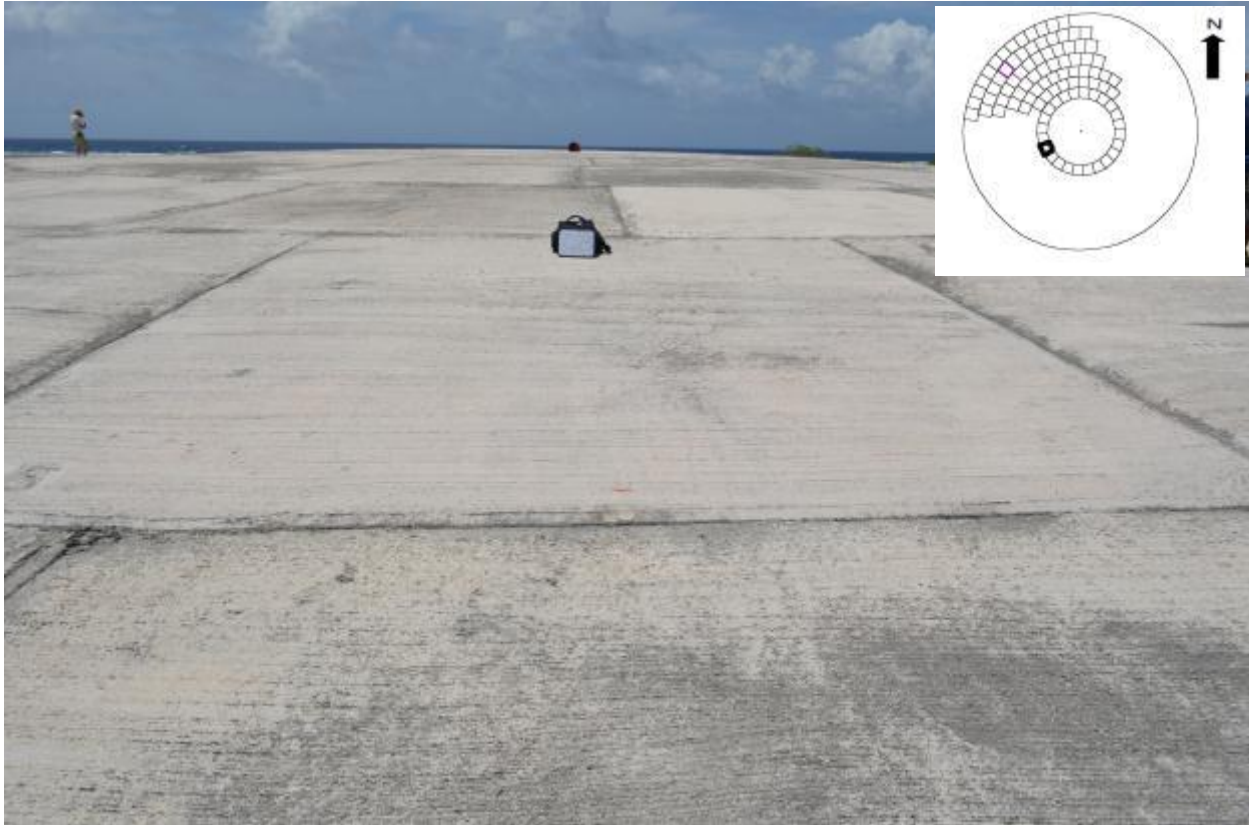
CAP SECTION LOCATION: Panel G26

Surface crack observed traversing up through the middle of the panel with a fork branching out to the left at a mid-point up the panel. Panel contains a vertical elevation benchmark.

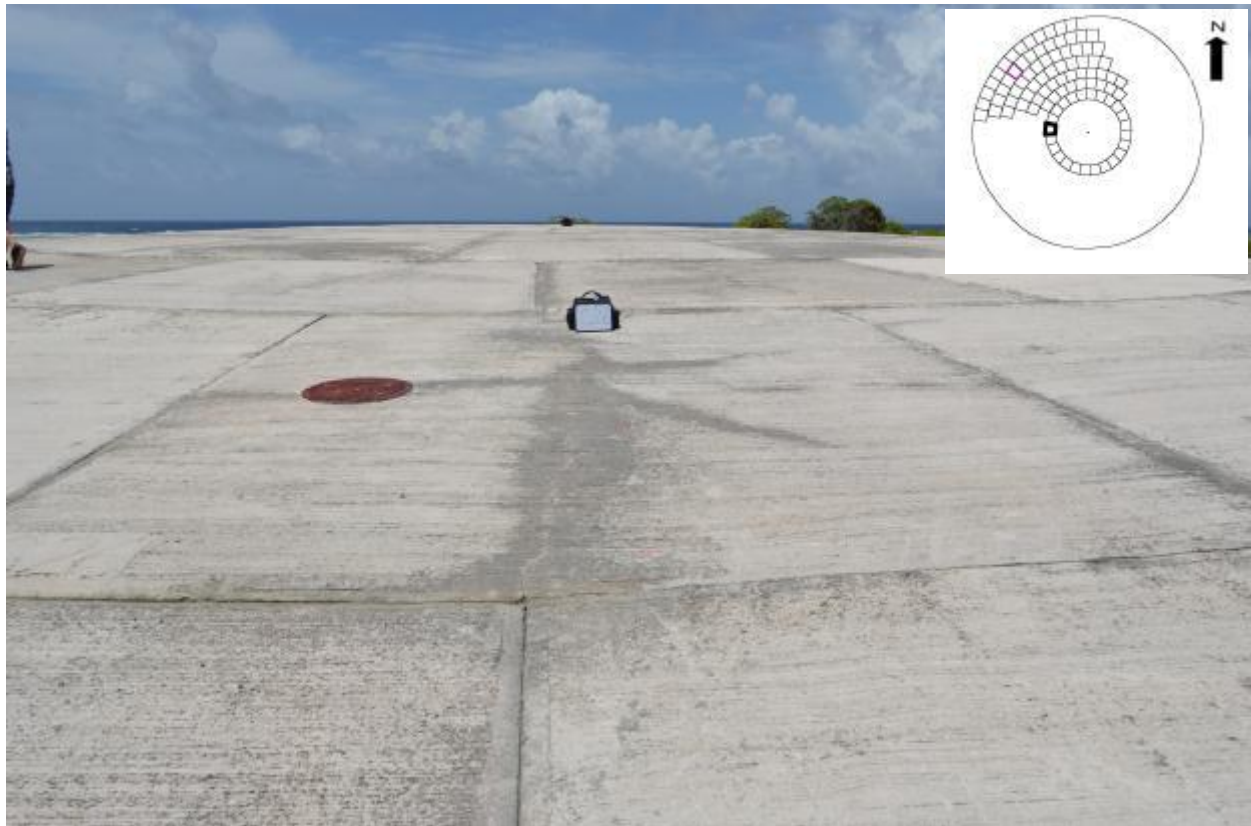
CAP SECTION LOCATION: Panel G27

Some spalling/cracking of concrete observed in the upper left corner. Surface crack observed traversing across the panel.

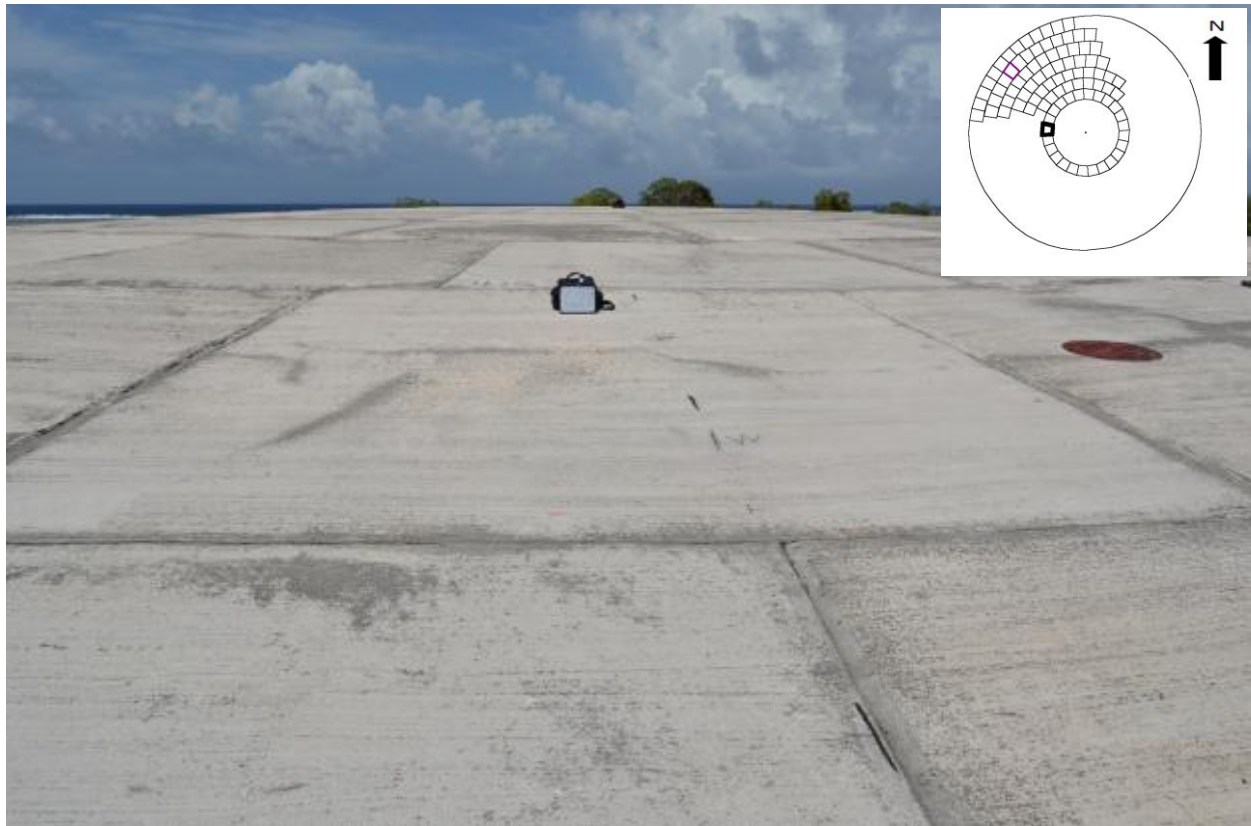
CAP SECTION LOCATION: Panel G28

Rooting vegetation removed from along the panel seams. No significant or obvious interior cracks or spall elements identified with exception of spalling/cracking of concrete in the upper right-hand corner of the panel.

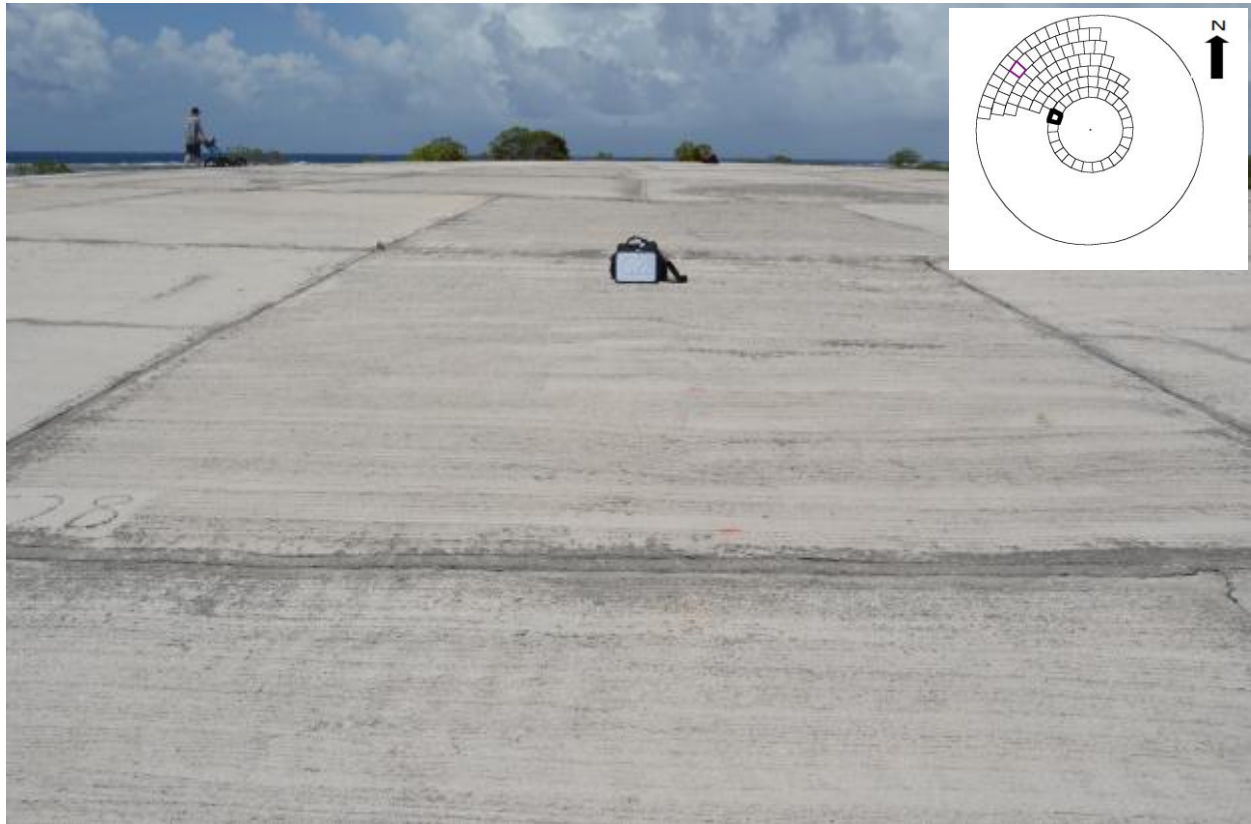
CAP SECTION LOCATION: Panel G29

Surface crack observed extending up through the middle of the panel from the left side of the bottom seam towards the upper right-hand corner with forks branching out to the left and right sides at about a mid-point up the panel. Rooting vegetation removed from along the panel seams.

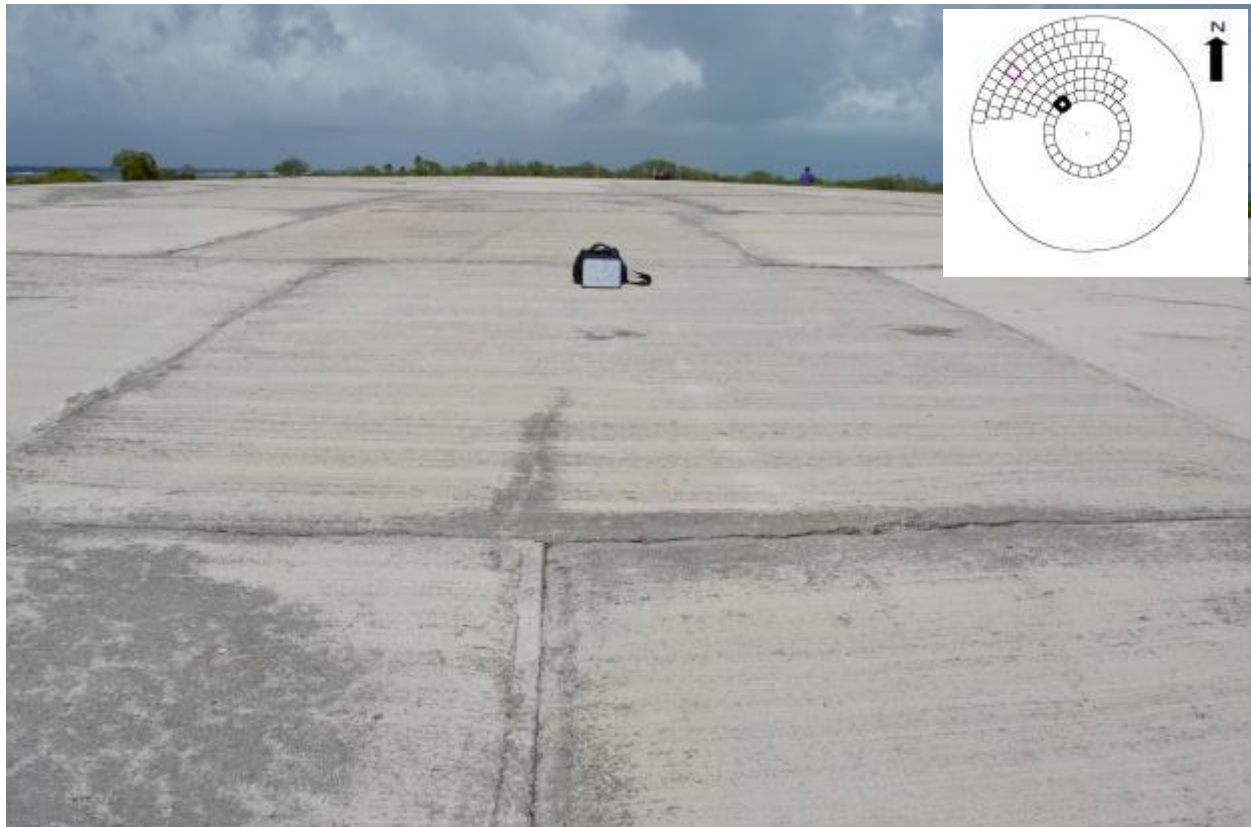
CAP SECTION LOCATION: Panel H1

No significant or obvious interior cracks or spall elements identified.

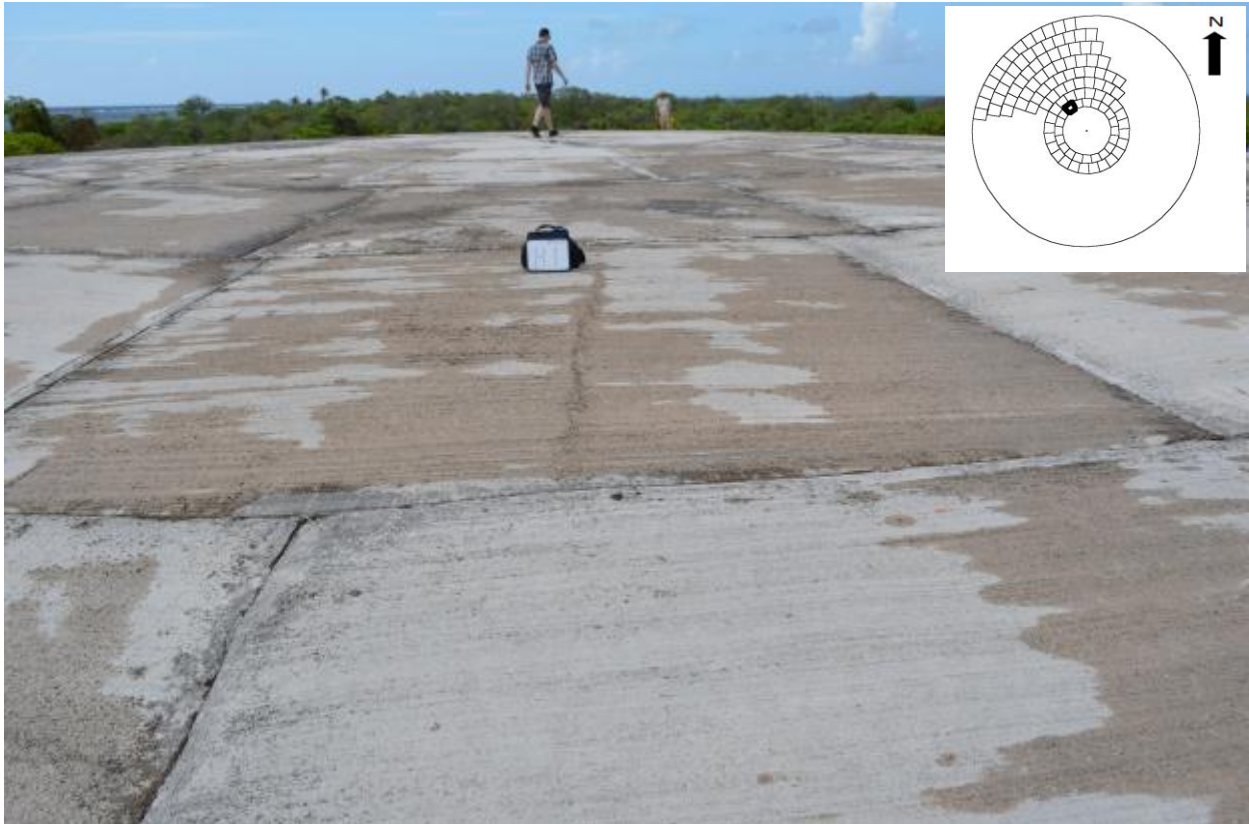
CAP SECTION LOCATION: Panel H2

No significant or obvious interior cracks or spall elements identified.

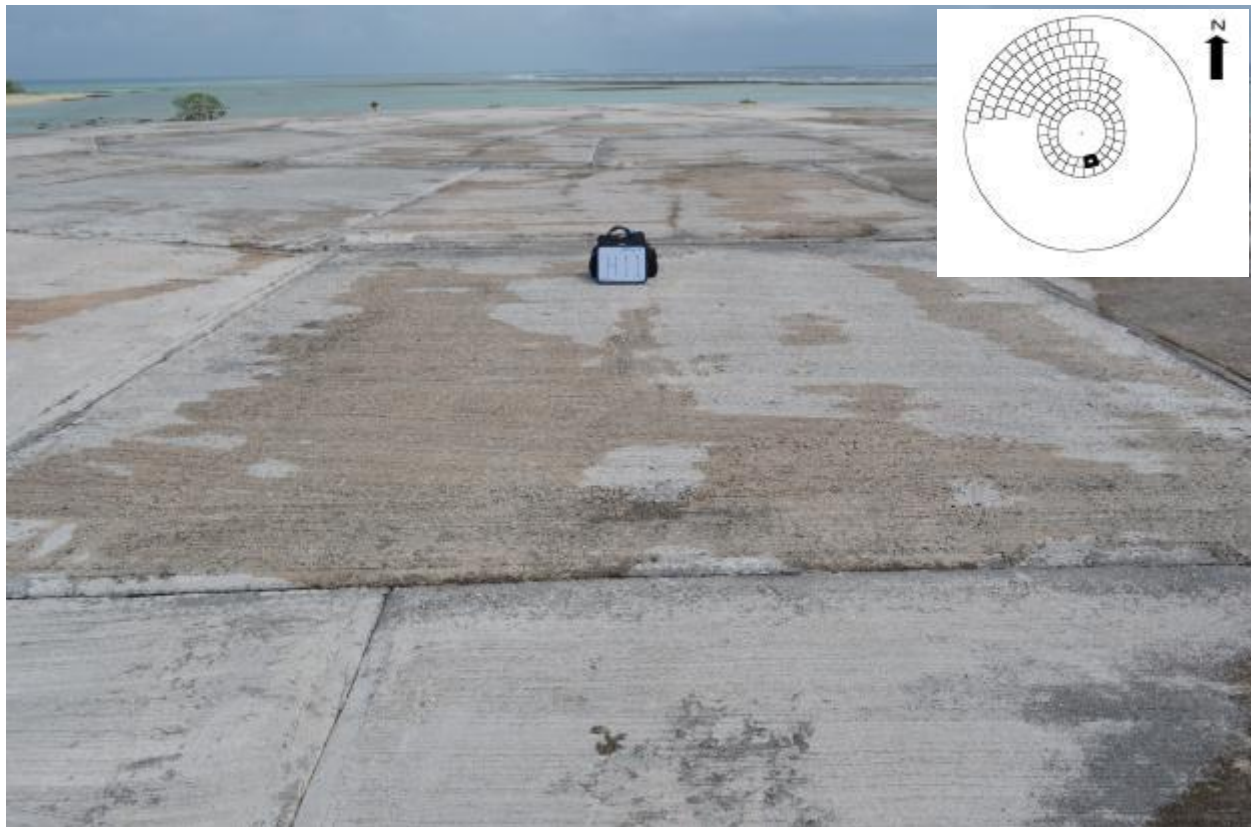
CAP SECTION LOCATION: Panel H12

No significant or obvious interior cracks or spall elements identified.

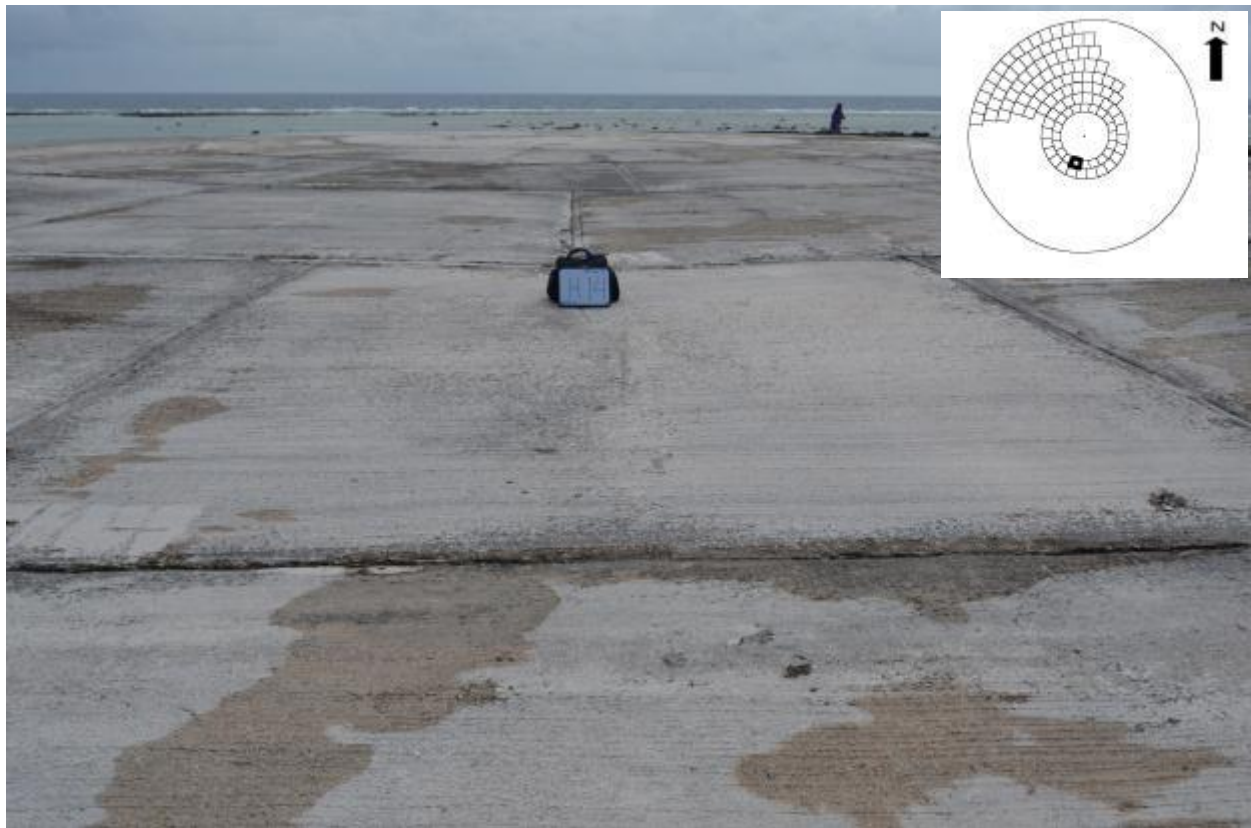
CAP SECTION LOCATION: Panel H15

No significant or obvious interior cracks or spall elements identified.

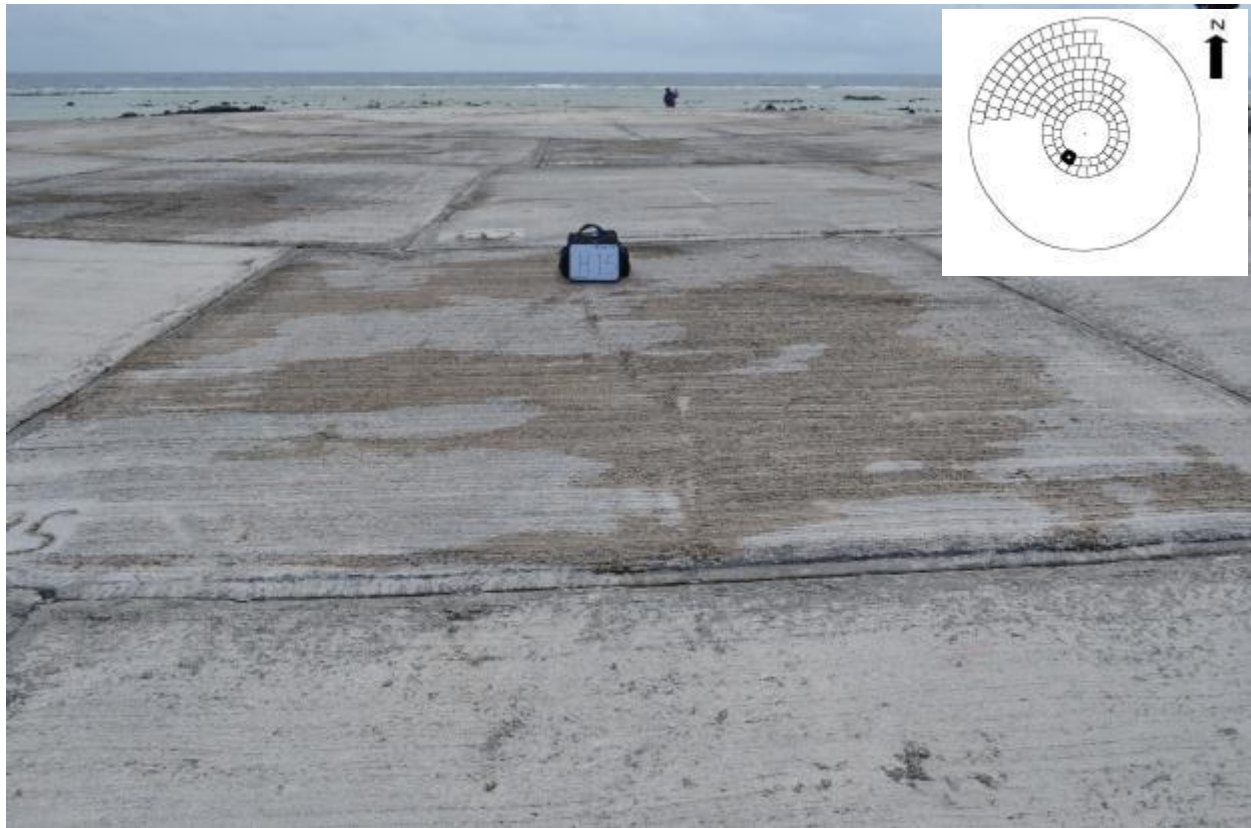
CAP SECTION LOCATION: Panel H16

No significant or obvious interior cracks or spall elements identified. Panel contains a filled concrete bore-hole (CD-7) from the 1980 NAS investigation.

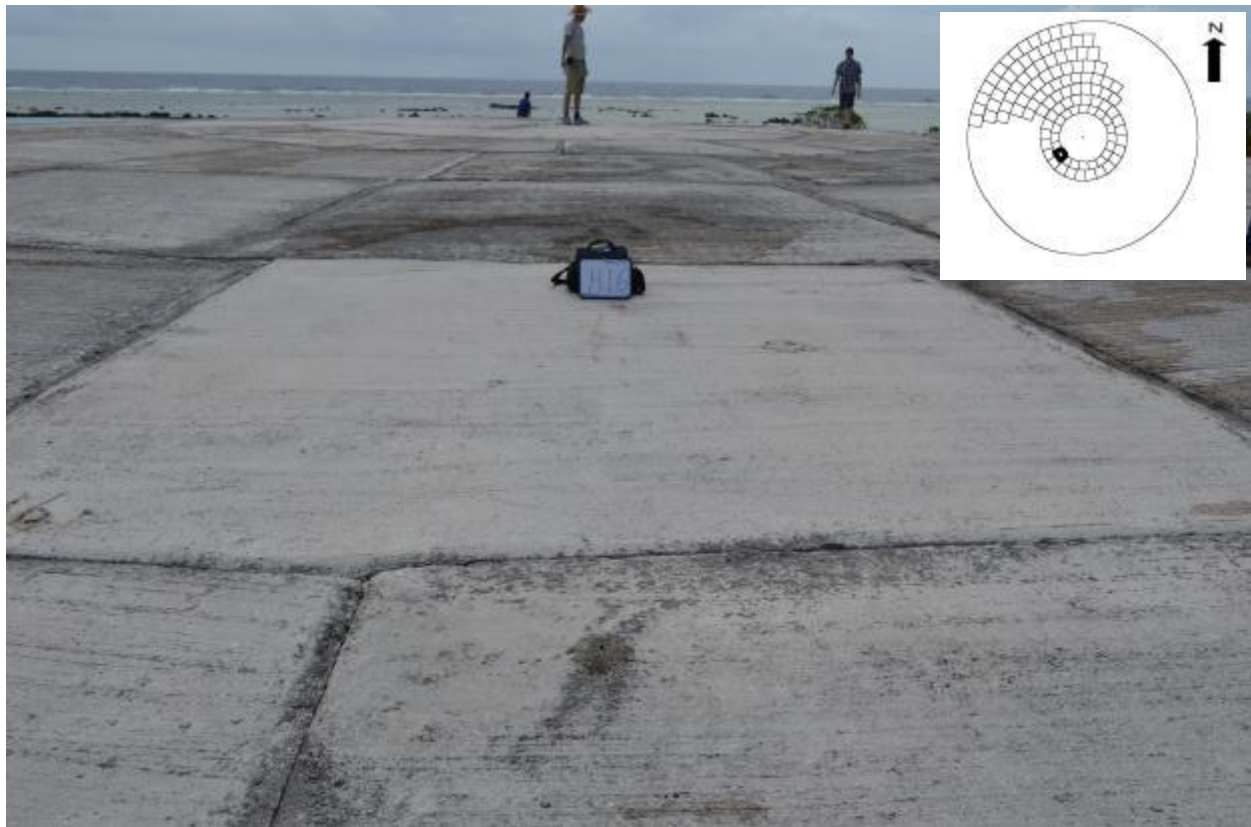
CAP SECTION LOCATION: Panel H17

No significant or obvious interior cracks or spall elements identified. Minor spalling/chipping of concrete in the upper right-hand corner.

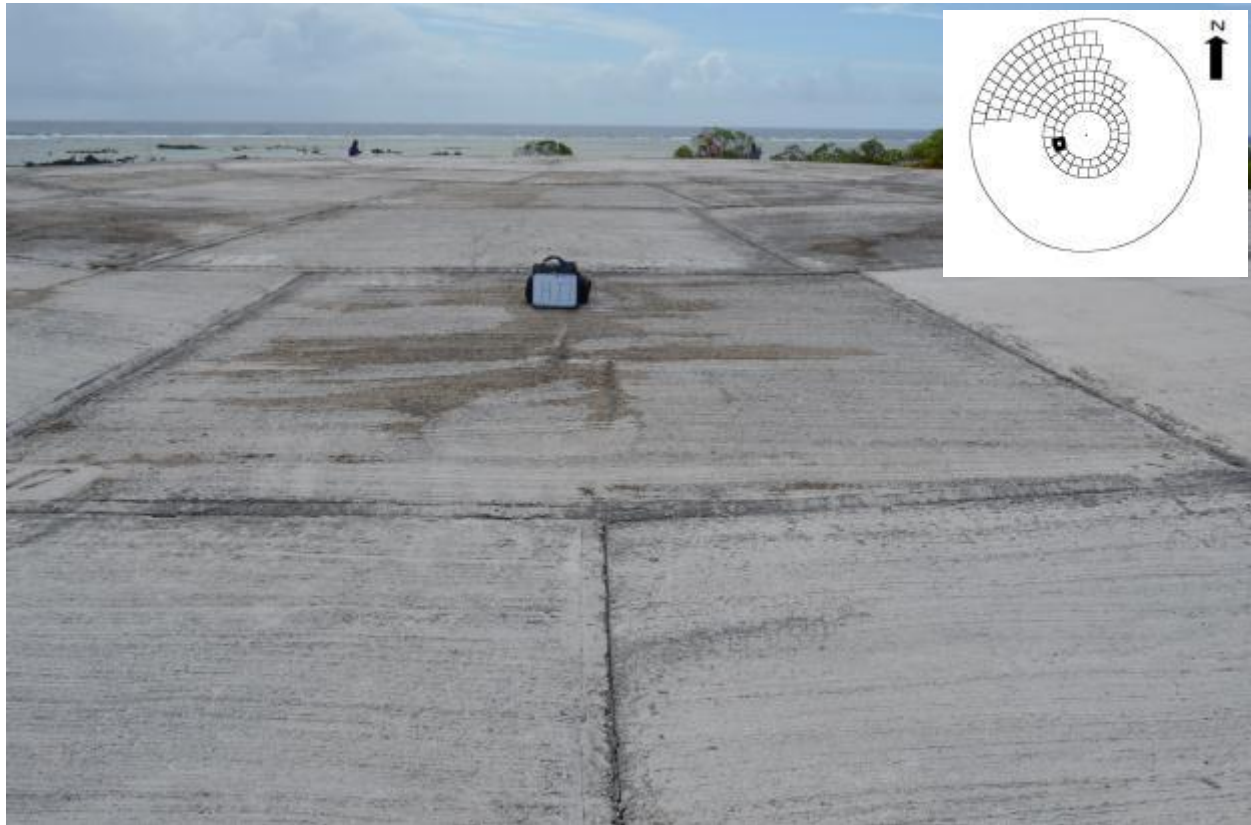
CAP SECTION LOCATION: Panel H18

No significant or obvious interior cracks or spall elements identified.

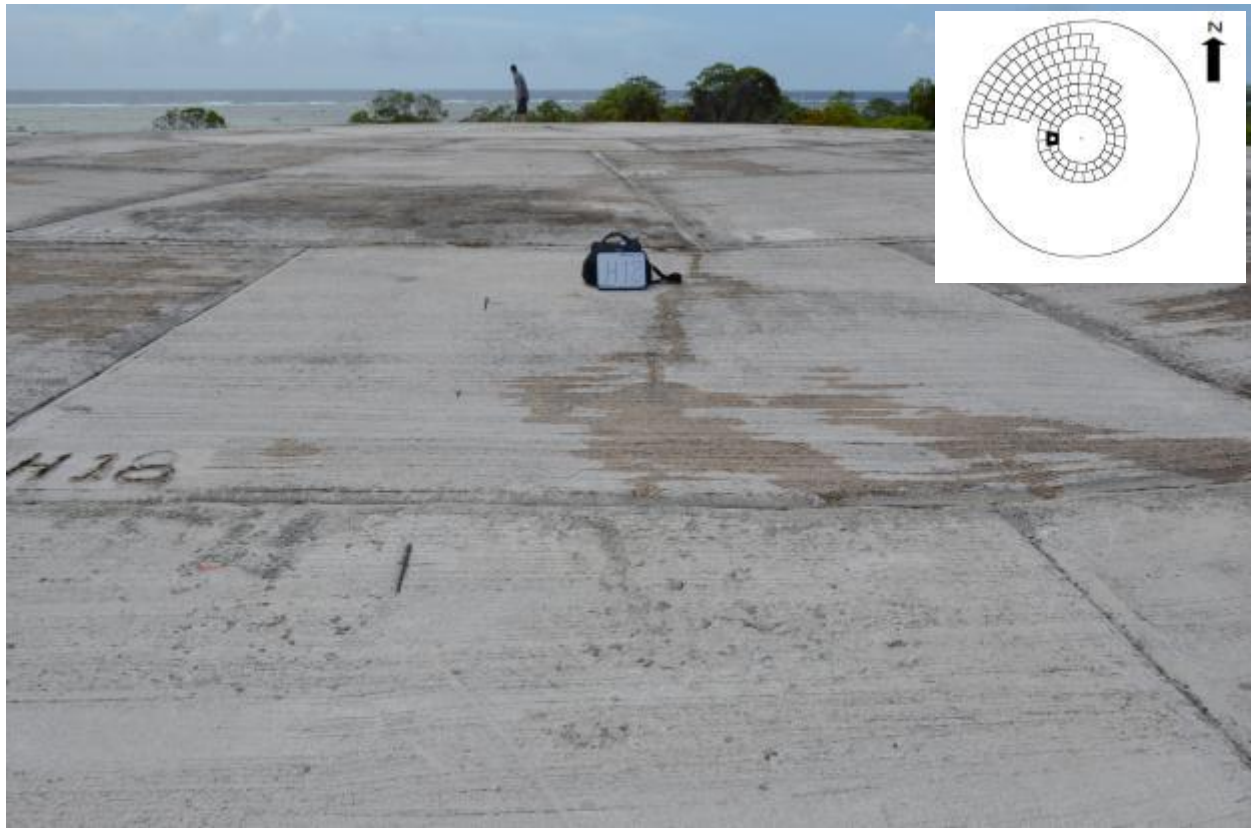
CAP SECTION LOCATION: Panel H19

No significant or obvious interior cracks or spall elements identified. Minor spalling/chipping of concrete in the top and bottom left-hand corners of the panel.

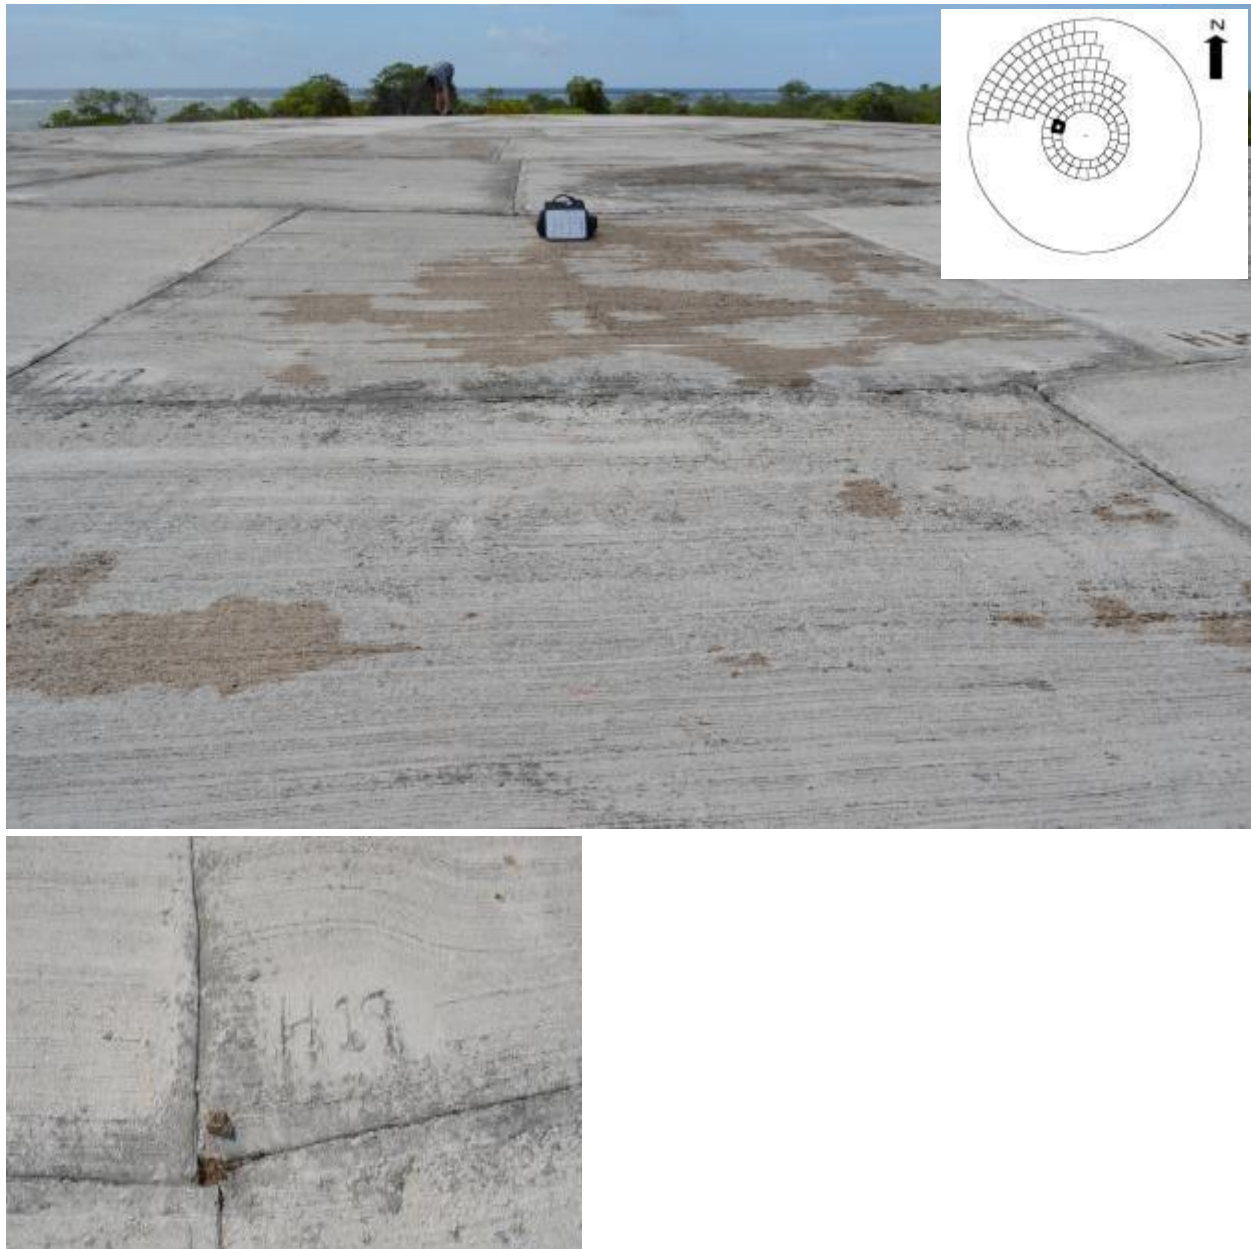
CAP SECTION LOCATION: Panel H20

No significant or obvious interior cracks or spall elements identified.

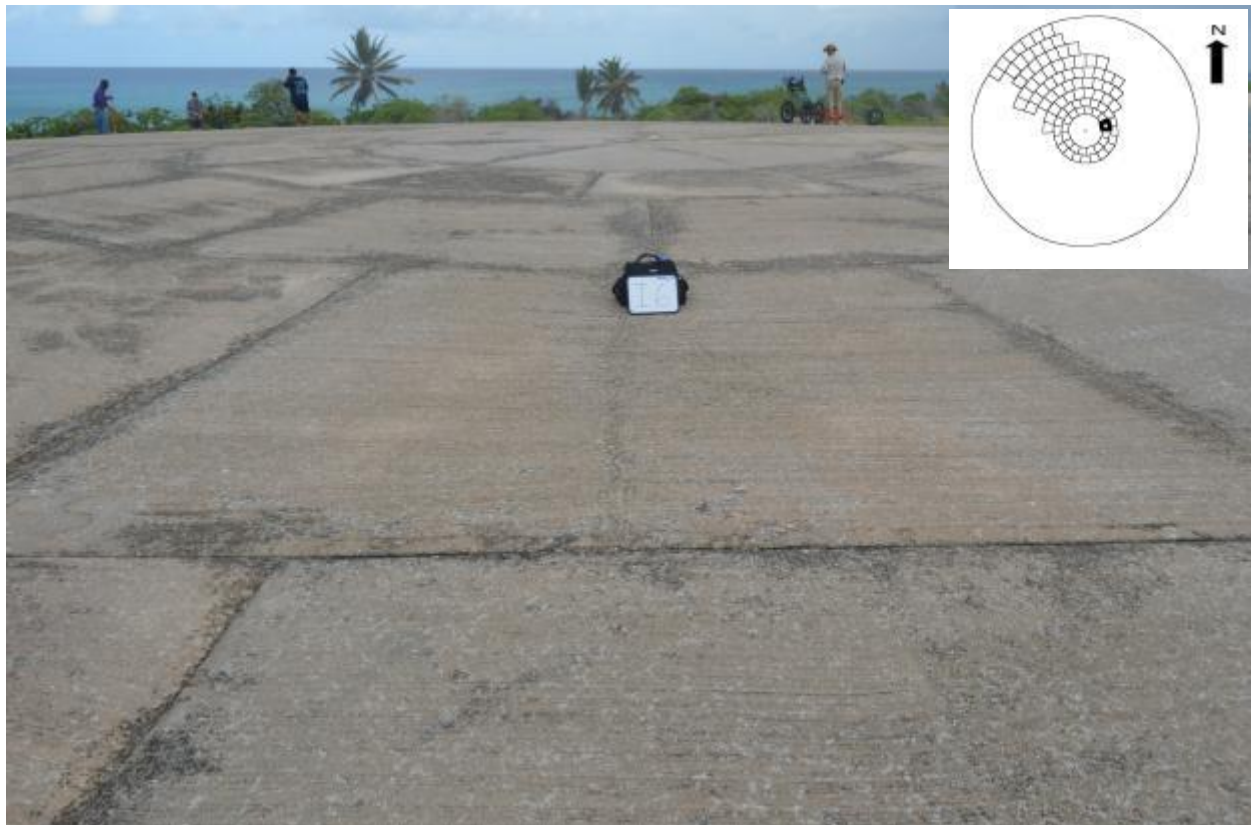
CAP SECTION LOCATION: Panel I7

No significant or obvious interior cracks or spall elements identified.

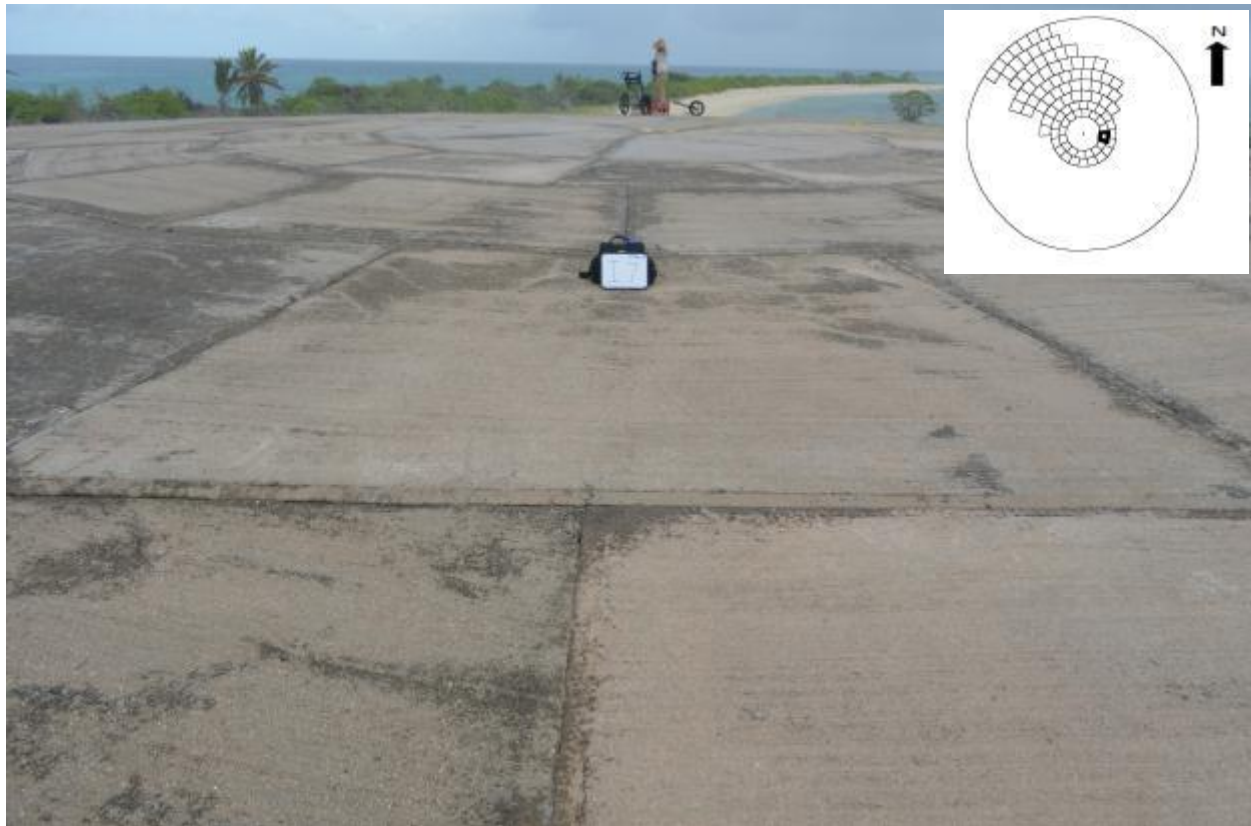
CAP SECTION LOCATION: Panel I8

No significant or obvious interior cracks or spall elements identified with exception of very minor spalling/chipping of concrete in the bottom left-hand corner of the panel.

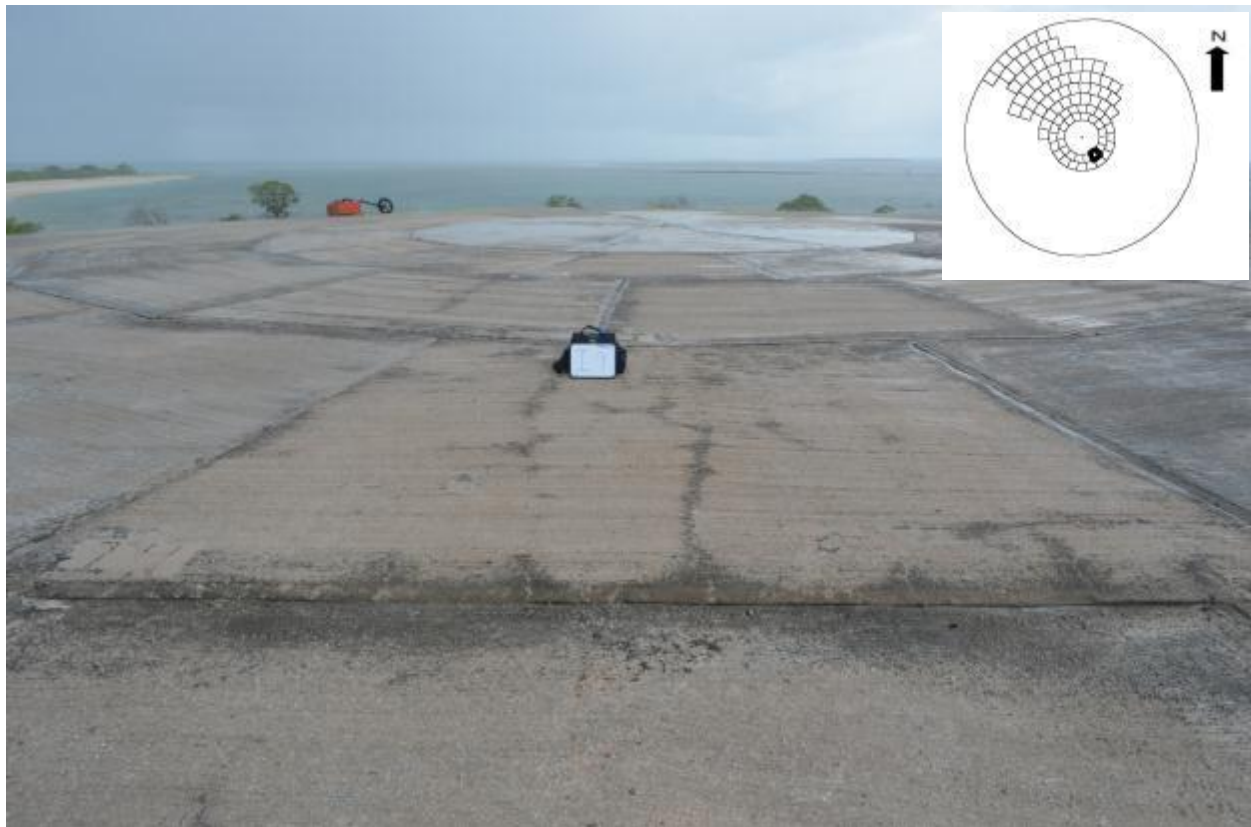
CAP SECTION LOCATION: Panel I9

No significant or obvious interior cracks or spall elements identified with exception of spalling/chipping of concrete in the bottom left-hand corner of the panel.

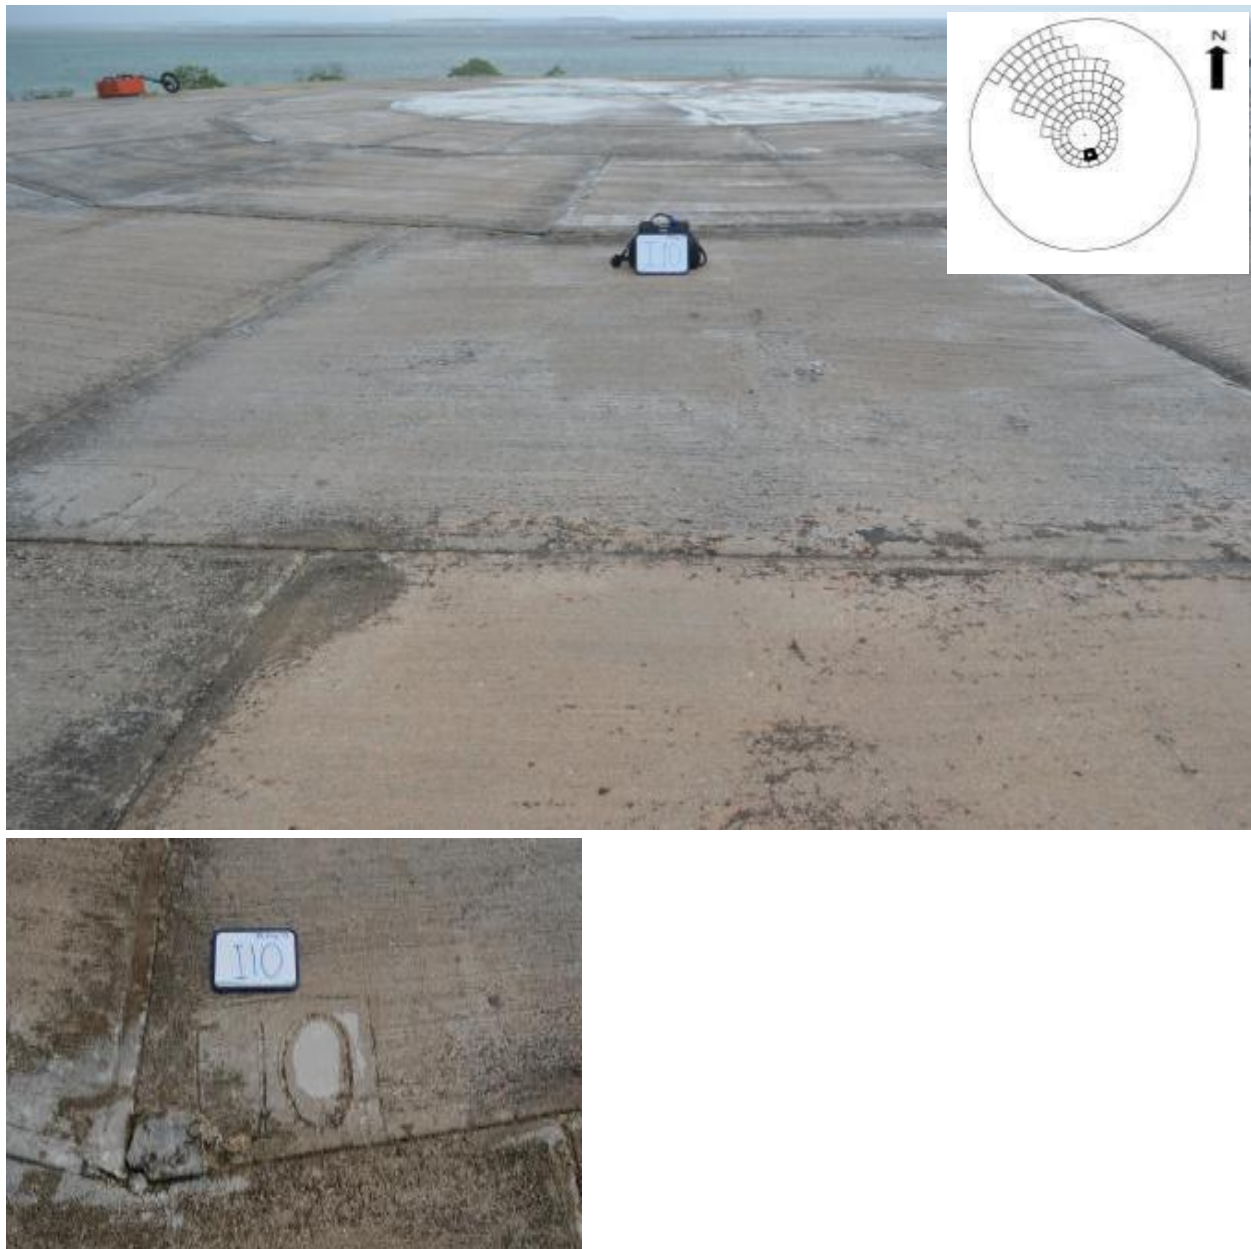
CAP SECTION LOCATION: Panel I10

No significant or obvious interior cracks or spall elements identified with exception of spalling/chipping of concrete in the bottom left-hand corner of the panel.

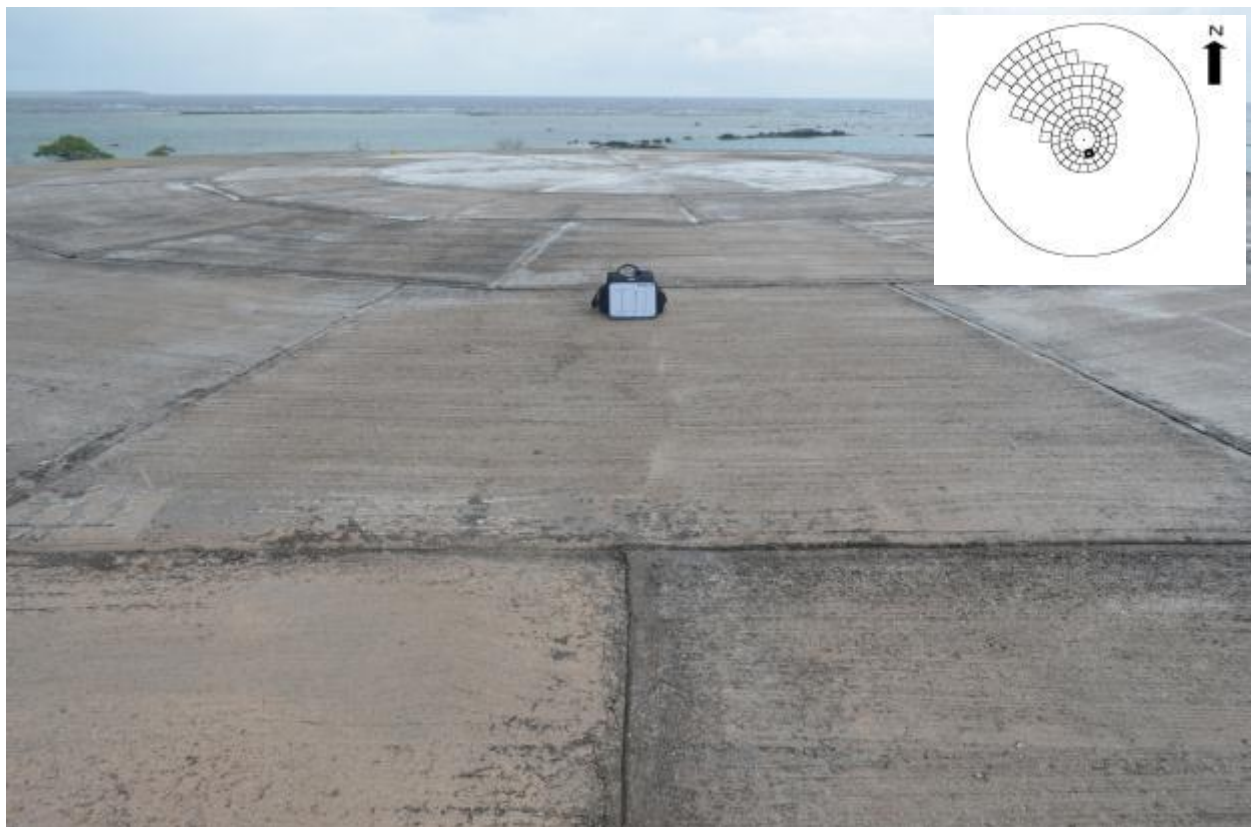
CAP SECTION LOCATION: Panel I11

No significant or obvious interior cracks or spall elements identified with exception of minor spalling/chipping of concrete in the bottom left-hand corner of the panel.

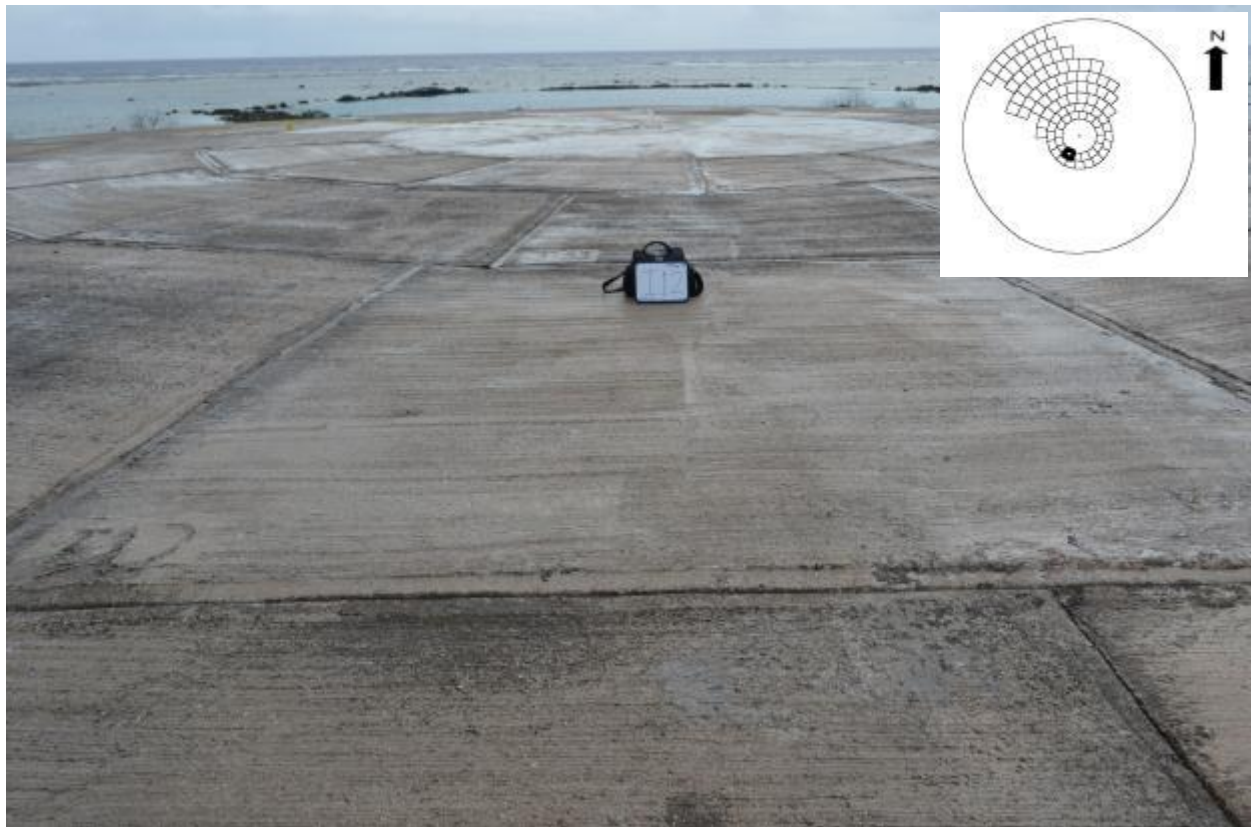
CAP SECTION LOCATION: Panel I12

No significant or obvious interior cracks or spall elements identified.

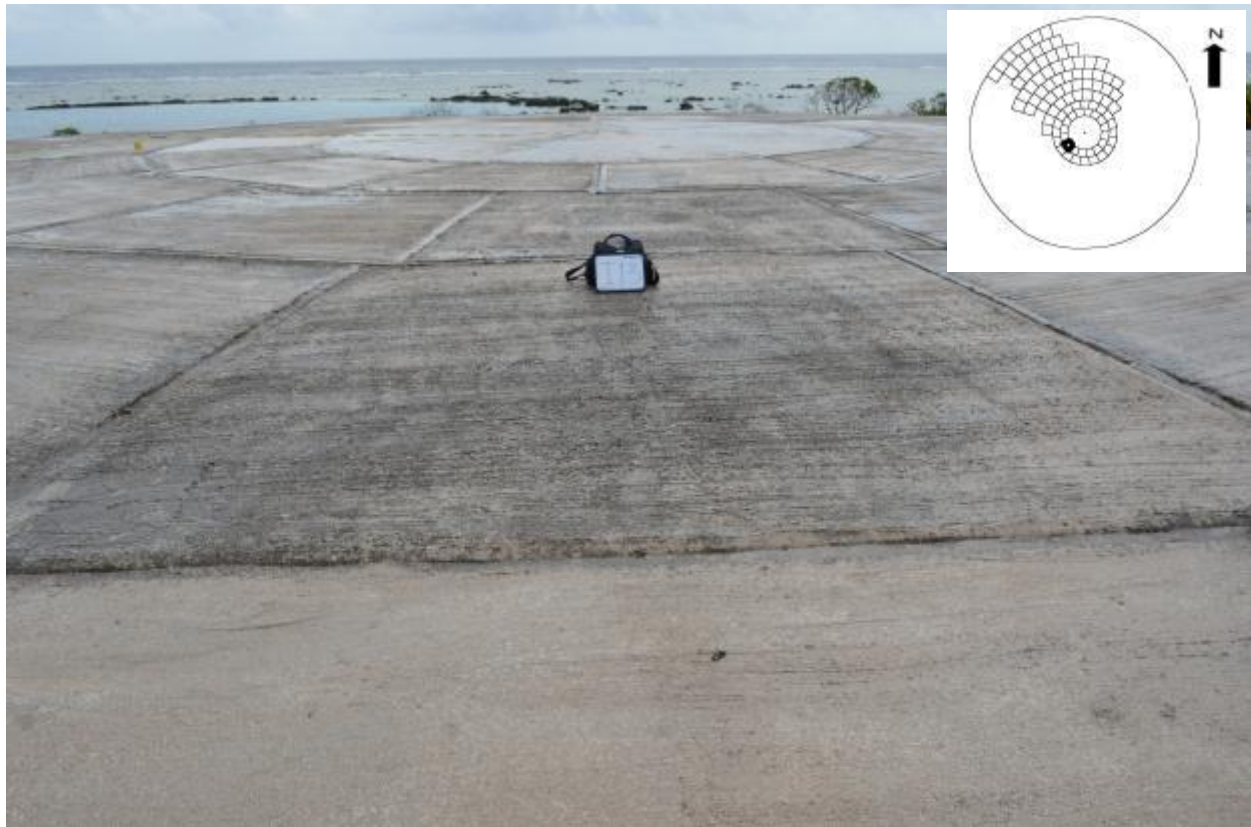
CAP SECTION LOCATION: Panel I13

No significant or obvious interior cracks or spall elements identified.
